**CONNECTICUT RIVER BASIN
HADDAM, CONNECTICUT**

**HIGGANUM RESERVOIR DAM
CT 00430**

**PHASE 1 INSPECTION REPORT
NATIONAL DAM INSPECTION PROGRAM**

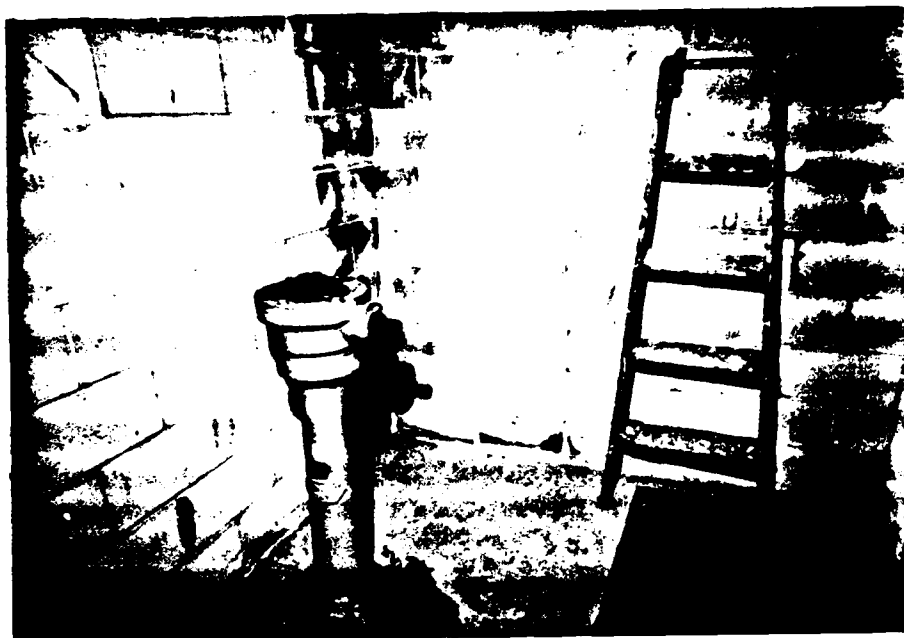
All gate operations at the dam are directed by the Hartford office of the Department of Environmental Protection (D.E.P.). The gate, reportedly, has not been operated since 1972. An operational check of the gate was performed at the time of the visual inspection and the mechanism and gate functioned satisfactorily. The gatehouse and lift mechanism appeared to be in good condition.

C-10 INTERIOR OF GATEHOUSE SHOWING GATE
OPERATING MECHANISM
